Case Study

Refractory Systems

Industry: Tunnel Kiln Roof Replacement
Location: IBSTOCK Brick - Cannock Staffs
Operating Temperature: 1100°C
Scope of Works: Roof Refractory Replaced 8mtr x 35mtr

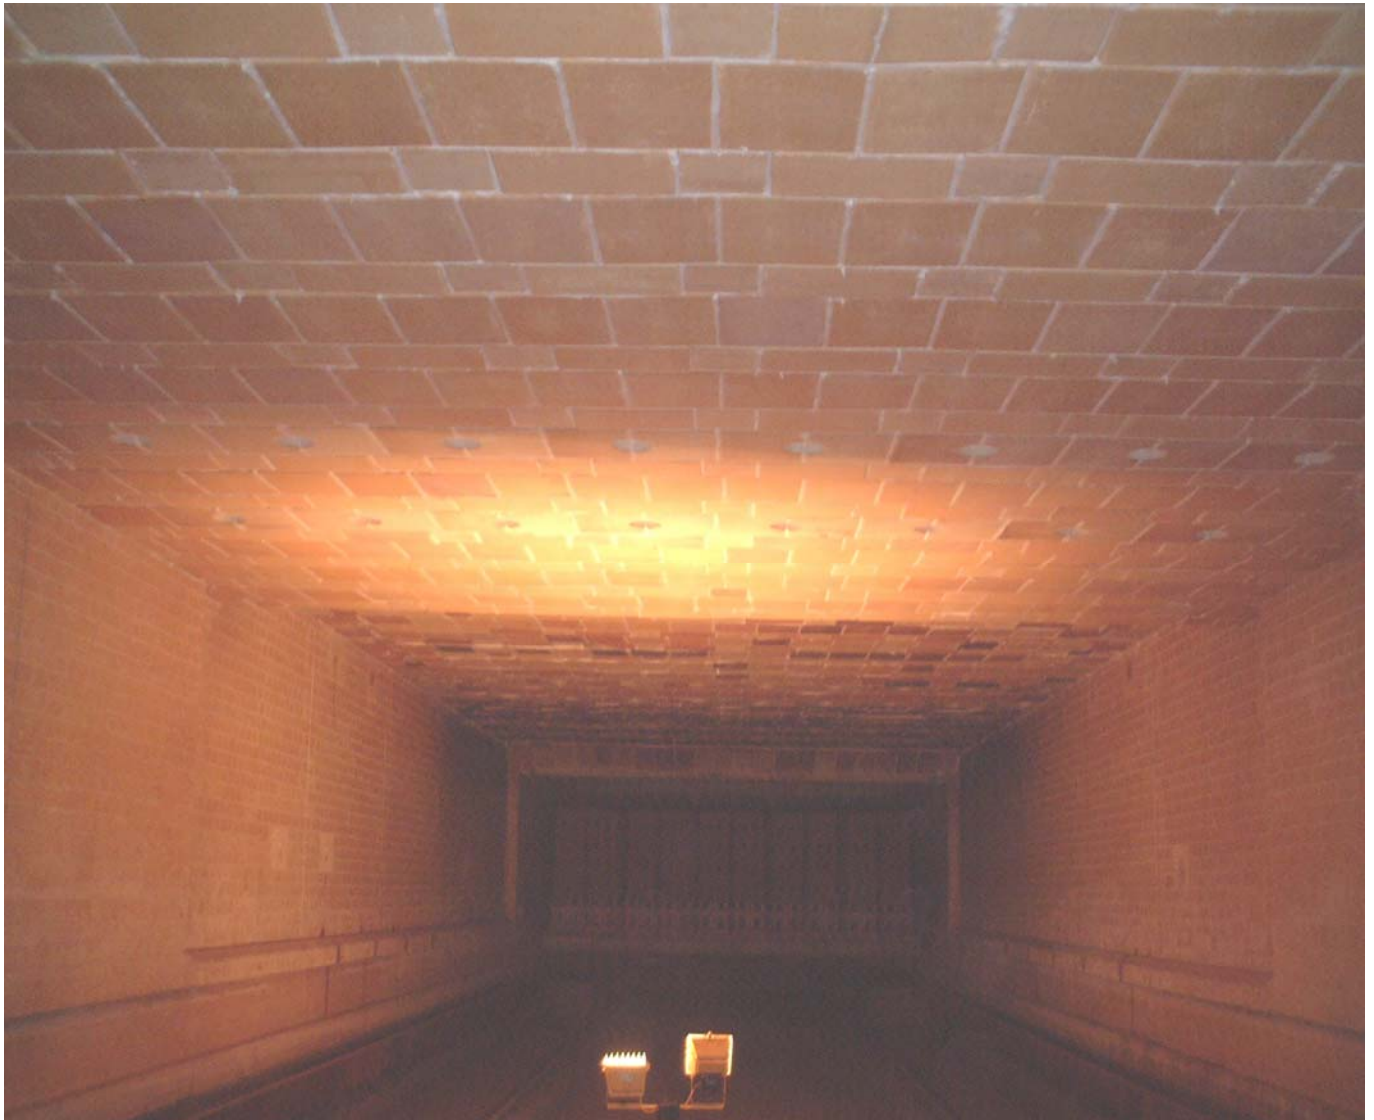
View on the last 12 mtr section of roof replaced.

The redundant refractory roof was removed due to anchor corrosion, new alloy cast clips were installed and the old roof refractories were replaced with new ceramic fibre insulation backup layered over the slabs.

The new insulation was installed to 250mm thick where as the old insulation was over installed at 400mm, this caused a cooking effect on the cast clips that held the roof in position which meant the replacement. The existing refractory lining has already seen some 15years service. It will now see at least a further 15 years service.

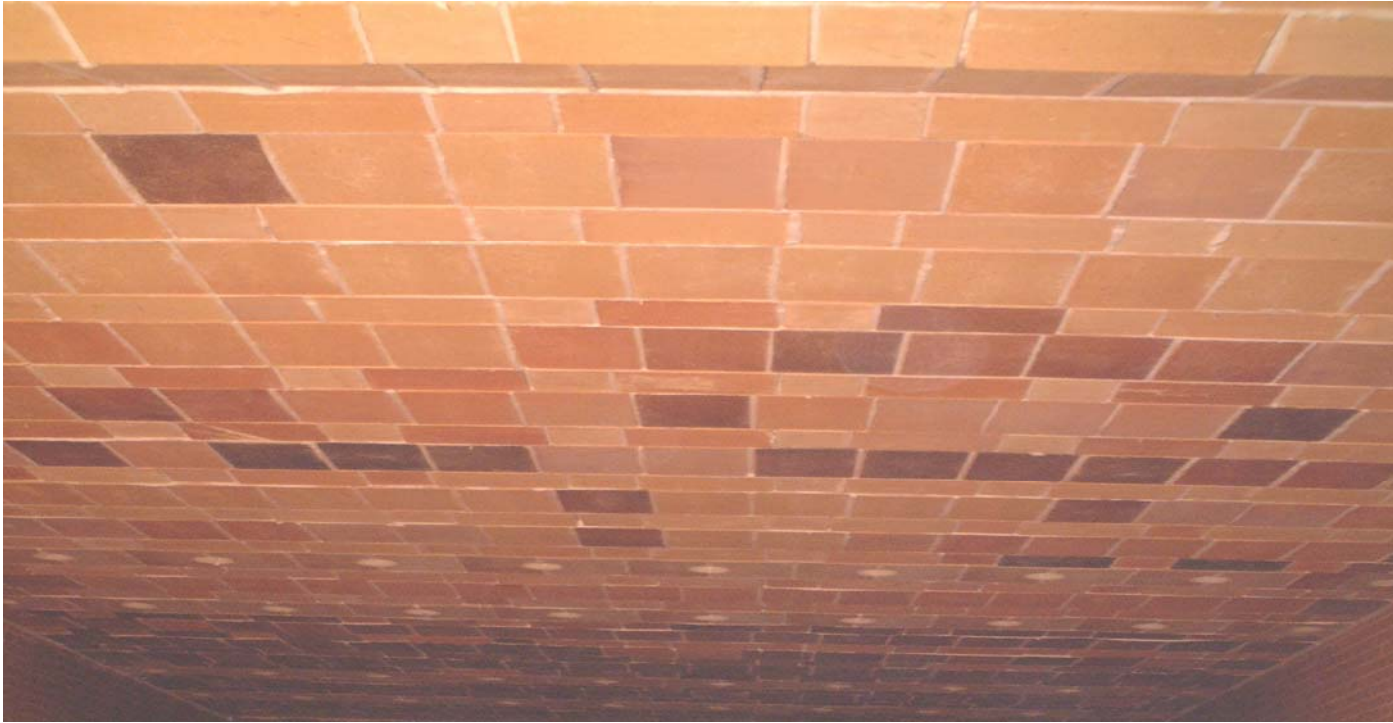
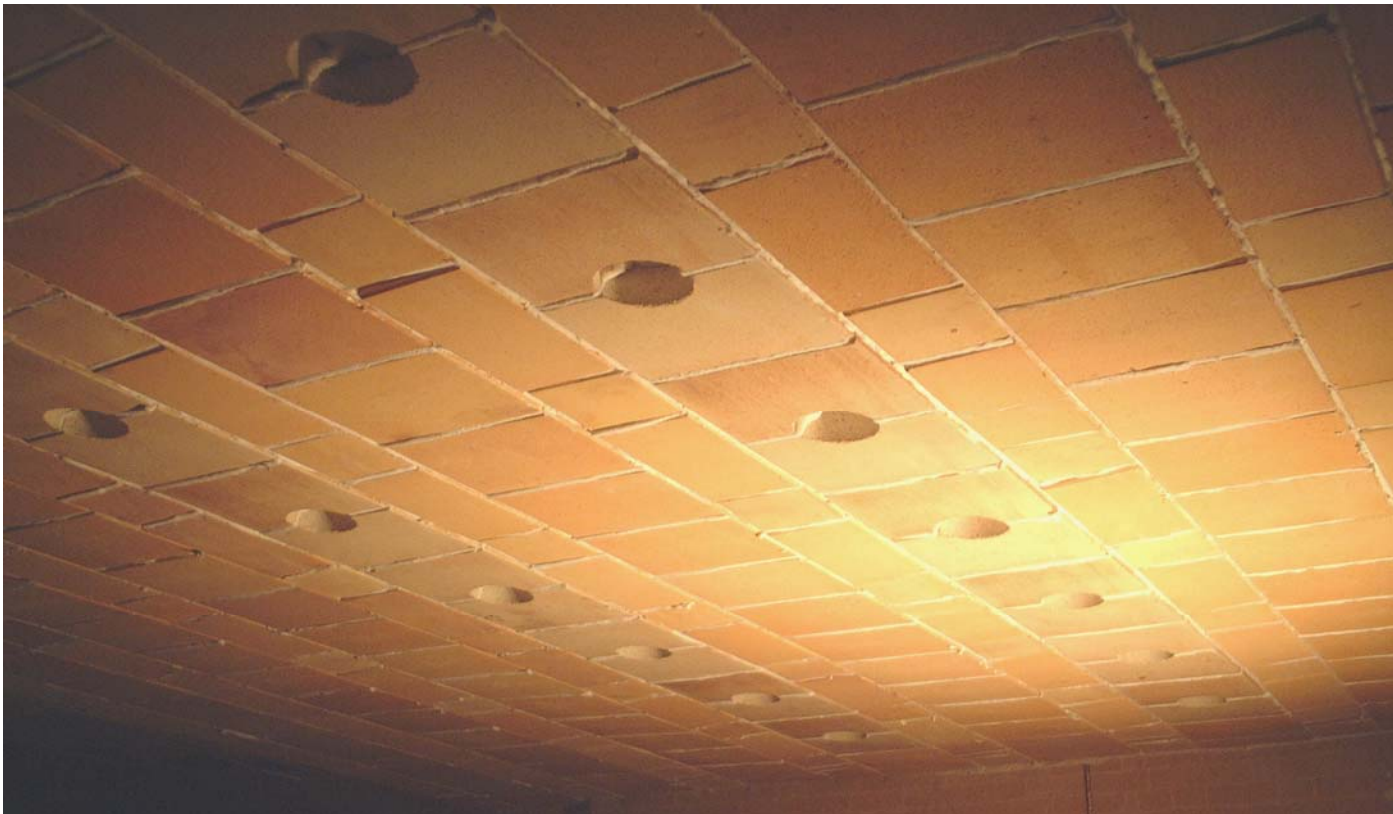
Tunnel Kiln Roof Replacement

Roof Refractory Replaced 8mtr x 35mtr
